CONNECTICAT River BASIN  
NEWINGTON CONNECTICUT

# MILL POND DAM CT 00164

## INSPECTION REPORT

MAY 1981

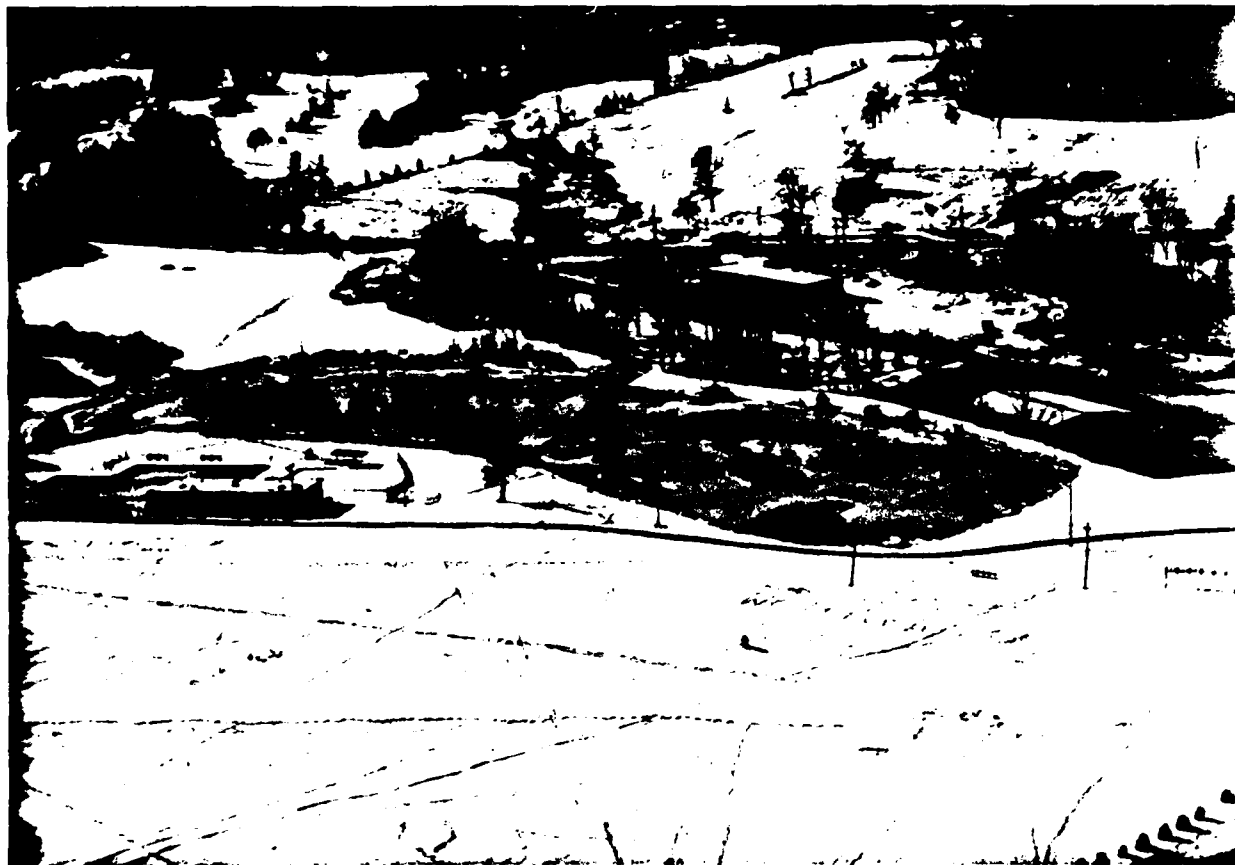
1.)VIEW OF DAM LOOKING DOWNSTREAM.

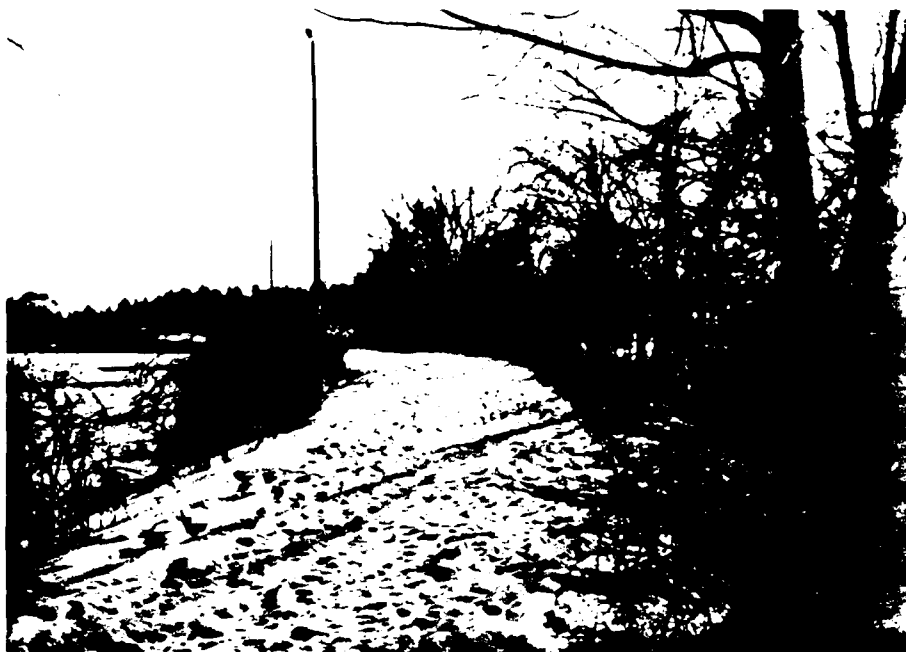
The downstream slope was very steep and covered with a large number of shrubs and trees, up to 18" in diameter (See Photo 1, 2 & 3). Remnants of a brick masonry wall partially retaining earthfill were observed along the downstream dam embankment as shown in Photo 4. The wall which is located on the general dam plan in Appendix B is founded on a rock base and appears to have been part of an old building. As shown in Photo 5, a four foot wide, rockfilled depression with a bottom approximately 8 ft. below the gravel path was observed on the downstream slope. The depression, which may at one time have been a sluiceway for the old waterpowered mills, showed no sign of seepage.

Photo 2 - View looking south along crest of dam.

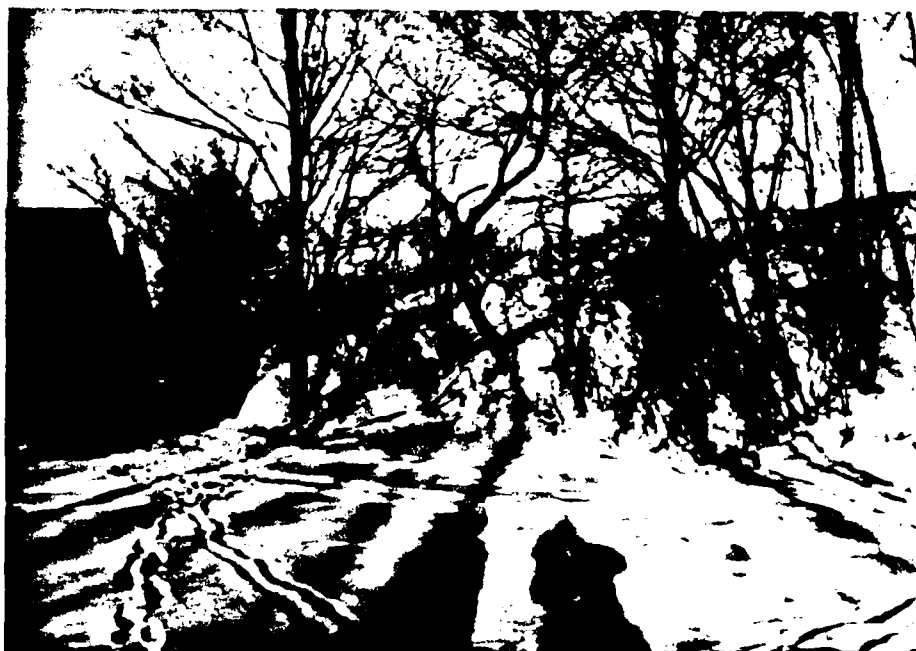
Photo 3 - View looking north along downstream side of dam showing outcrops of bedrock.

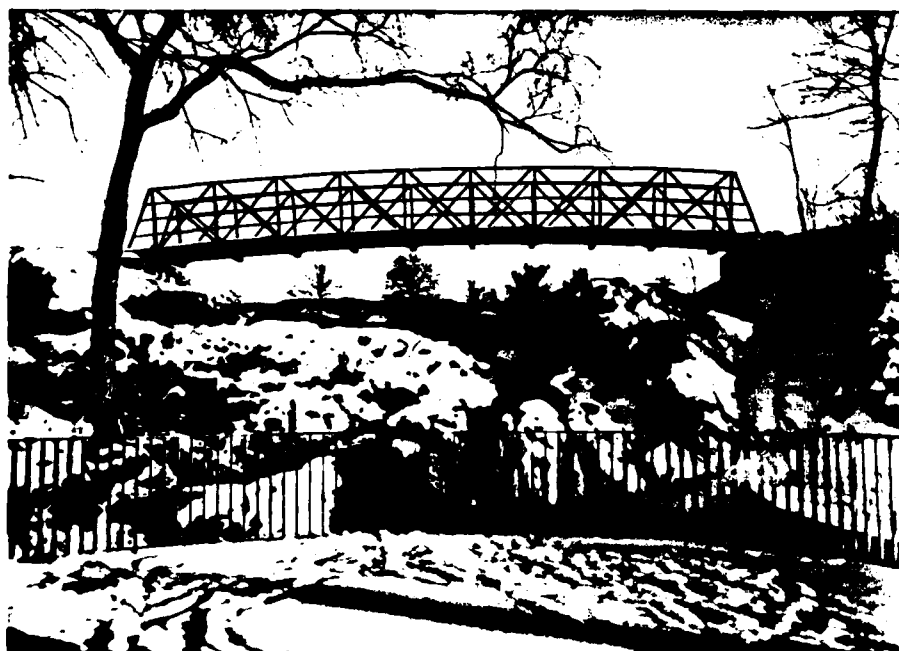
The spillway, which is an irregular natural rock formation, is in good condition with no signs of loose rock or unusual wear (See Photos 7 & 8). Extending over the spillway, the wood and steel footbridge was also in good condition. There was no evidence of any cracking or spalling of the concrete footing or abutments which can be seen in Photo 8. The wooden walkway and railings and the steel supporting substructure were well painted and appeared structurally sound.

Immediately downstream from the spillway, the rocky discharge channel was generally clean with a few trees overhanging the channel (See Photo 7).

Photo 7 - View of natural rock spillway and foot-  
bridge over spillway.

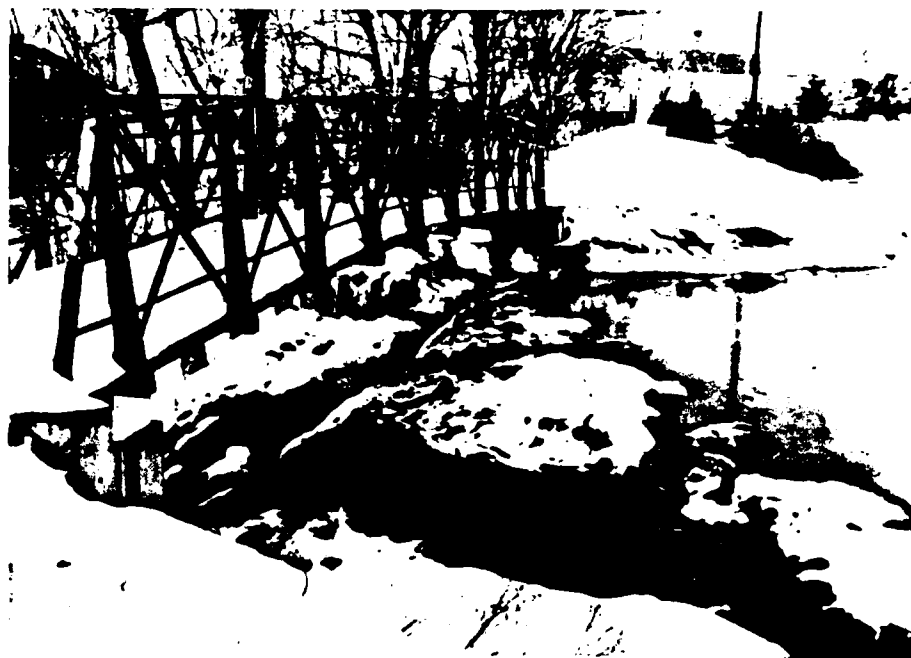
Photo 8 - Spillway Crest - Natural Rock

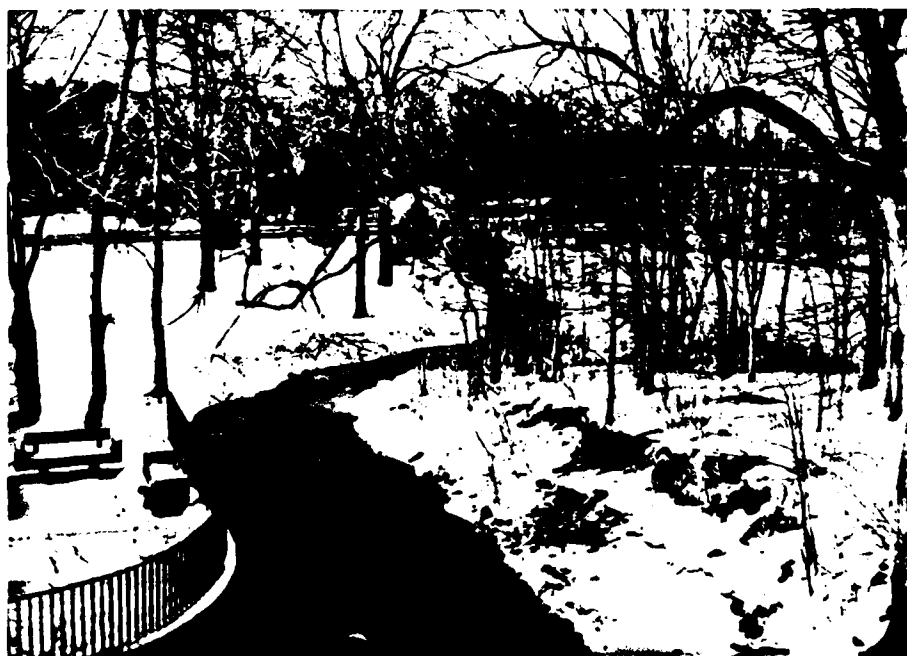
Consisting of a rocky bottom and grass lined slopes, the downstream channel (Mill Brook) is generally in good condition. As can be seen in Photo 9, moderate erosion was observed along the north bank of the channel immediately downstream from the spillway. Across the channel from the eroded area is the recently built concrete patio which is in good

condition as shown in Photos 7 and 9.

Photo 9 - Downstream Channel

1. Institute a formal program of maintenance procedures and fully document it to provide accurate records for future reference.
2. Remove trees and shrubs and their root systems in the vicinity of the rock filled depression.
3. Repair eroded area along the north slope of the downstream channel.
